# SF Rush the Rock

## Field Service Bulletin

### U17 Heatsink

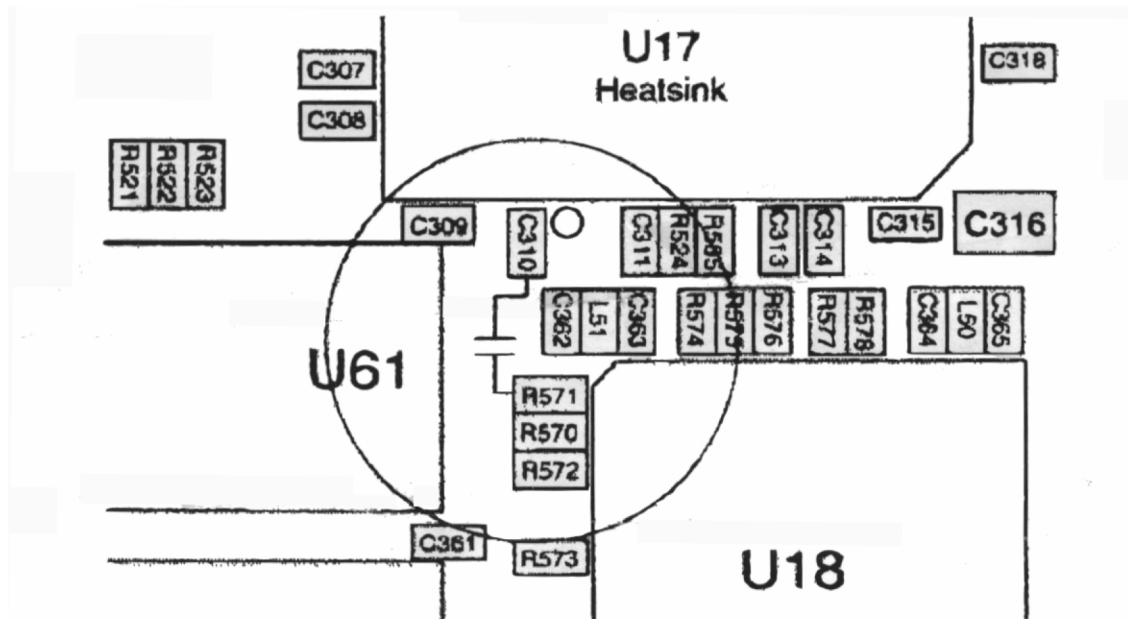
It has come to our attention that some **SF Rush the Rock CPU** boards (PN. #'s A-21937) may exhibit a reset problem. Symptoms are: the game freezes then re-boots during game play. To fix this timing error, solder a 10pF 10% axial capacitor (part # 5048-12503-00) from the load side of R571 to the ground side of C310. See below for an exploded view of the exact location on the board of the added capacitor.
